Manhole Inspection Summary

Manhole # S25SS1011MH

Insp Date: **3/14/07 3:22 PM**

Location Address: **4903 ROLAND AVE**

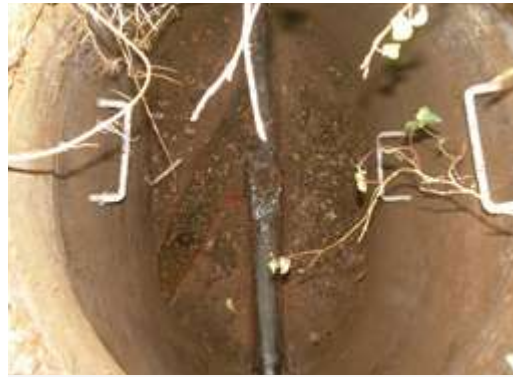
Top View

☐ Parged ☒ **Debris** (not Condition related)

☒ **Debris** (not Condition related)

Count: **4** Missing: **1** ☐ Corroded

Missing step. Bench and Channel debris.

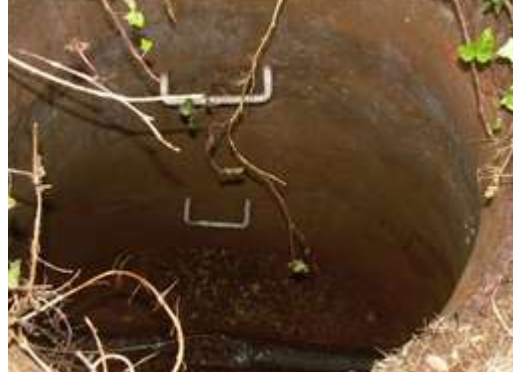
Defect

Infiltration: ☐ None ☒ **Joint** ☐ Cracks ☐ Mortar ☐ Roots ☒ **Wall**

Adjustment infiltration.

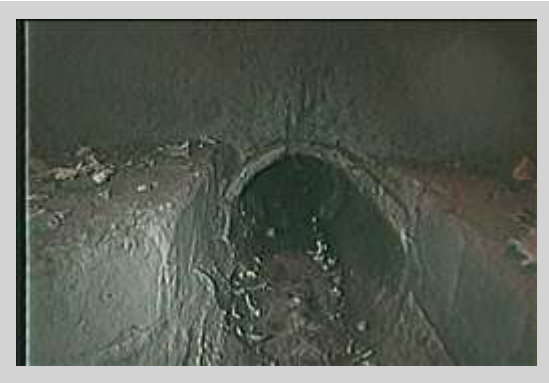
6 in. Circular Gravity Sewer Pipe Out @ 12 O'Clock

Deposits: ☐ None ☒ **Mud** ☐ Sludge ☒ **Debris** ☐ Grease

Infiltration: **Evidence** Pipe Seal Cond: **Cracked**

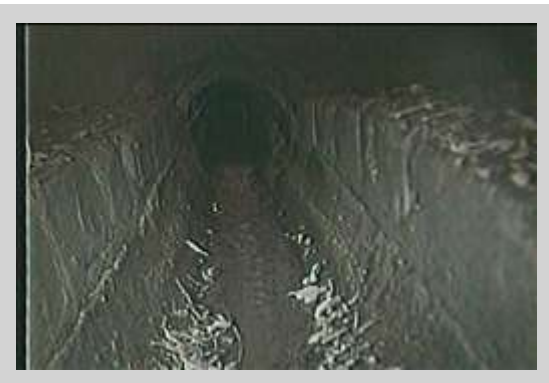
6 in. Circular Gravity Sewer Pipe In @ 6 O'Clock

Channel deterioration.

Infiltration: **Evidence** Pipe Seal Cond: **Cracked**

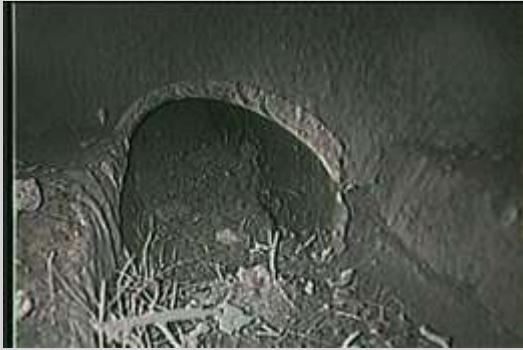
6 in. Circular Gravity Sewer

Deposits: ☐ None ☒ **Mud** ☐ Sludge ☒ **Debris** ☐ Grease

Silt Depth: **2** (in.)

Deposits Extent: **Medium**

Connects To: **Stub connection / abandoned**
